FLIGHT DECK REFUELLING HOSE FAILURE HMCS PRESERVER

Technical Memorandum

DREA TM 2000-022

January 2000

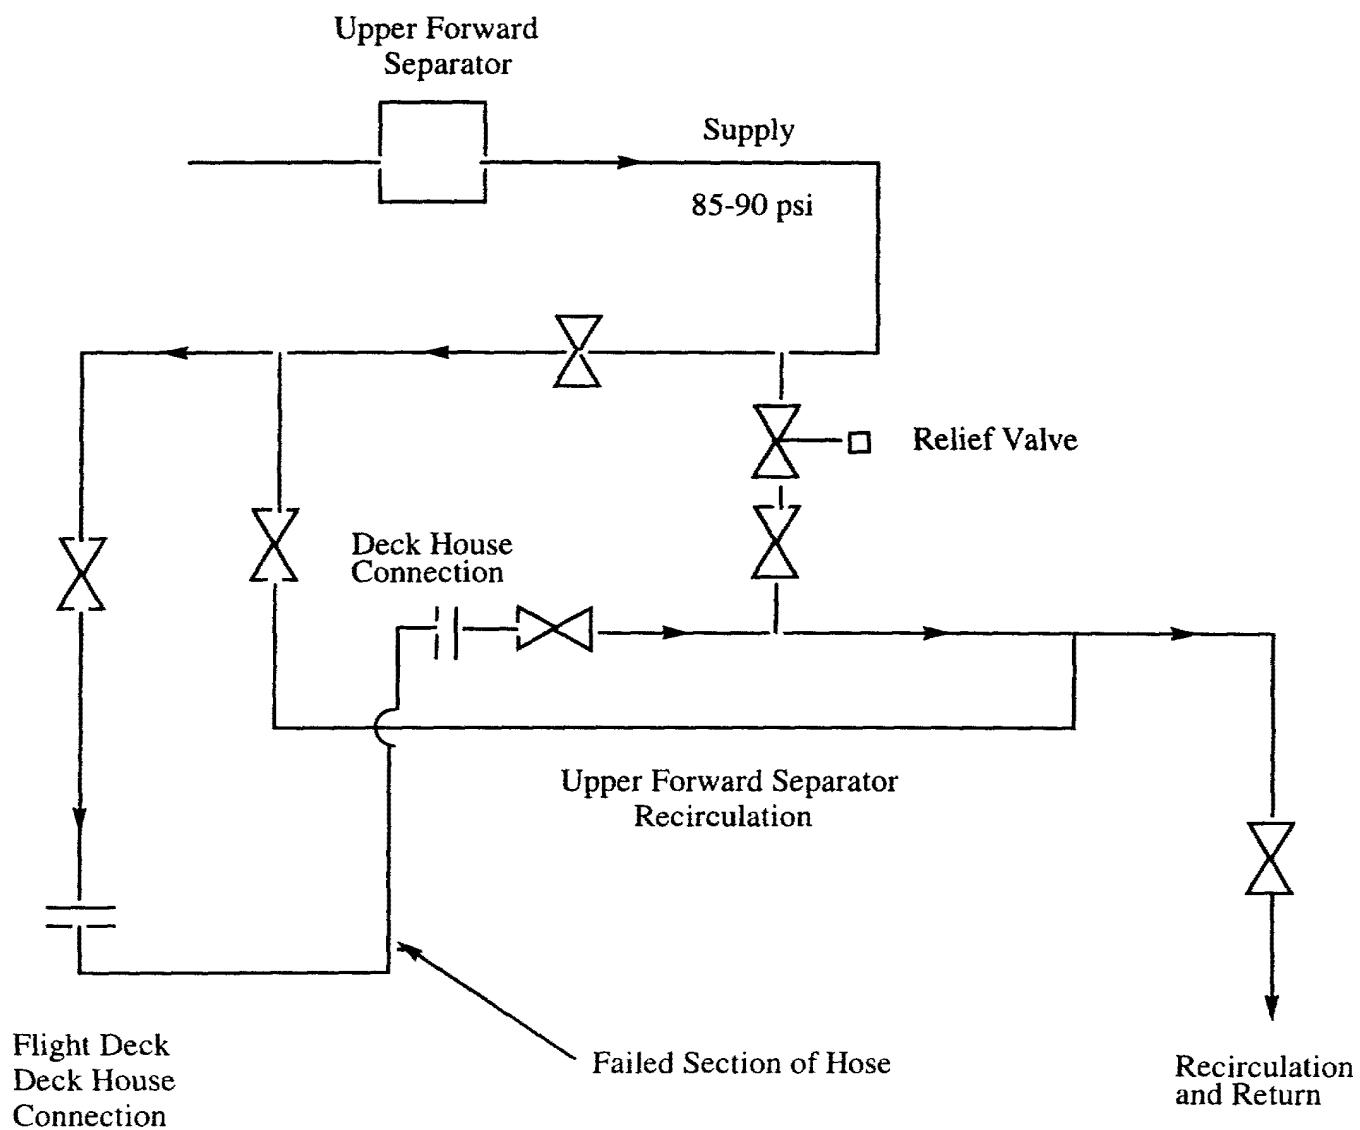
Figure 1 - Diagram of the flight deck aviation fuel delivery system HMCS Preserver.

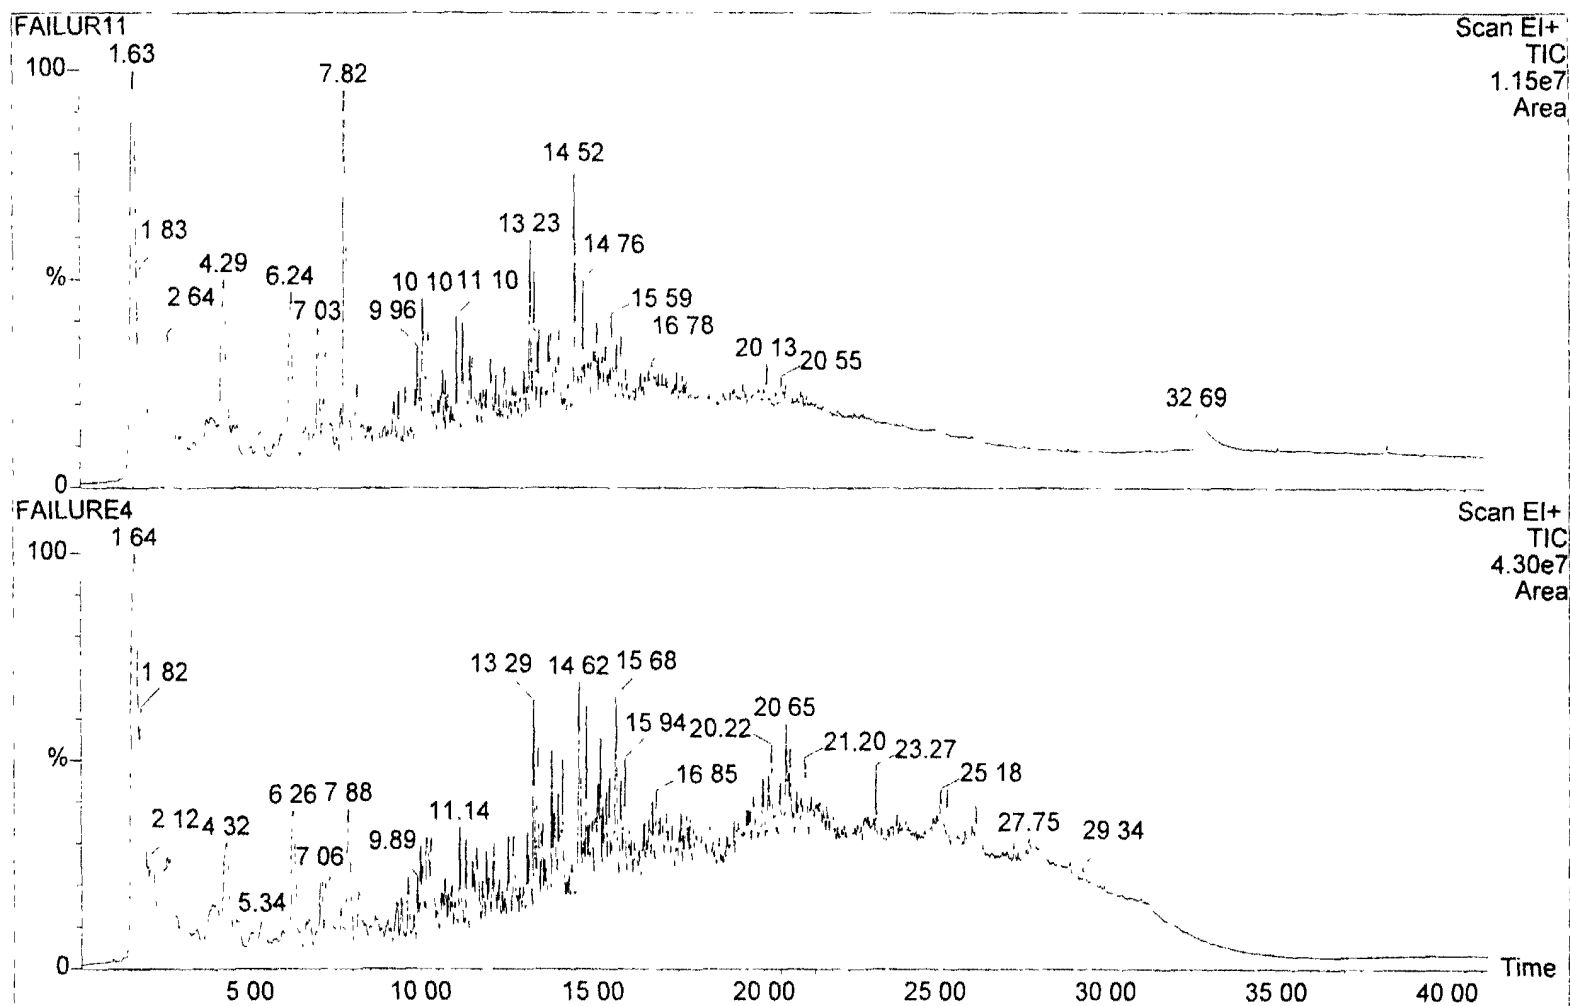
The analysis of the outer cover, inner tube and reinforcing fibres were repeated for another length of Titan MIL-H-6615E hose taken from stores. The markings on this hose indicated that it was from the same batch of hose as the failed refueling hose from HMCS Preserver. The pyrograms of the outer cover, inner tube, and reinforcing fibre are shown in Figures 7a through 9a respectively. For comparison the pyrograms of the corresponding material from the hose failed in service are shown in the Figures 7b through 9b. The similarity of the pyrograms of the outer cover, inner tube and

Figure 7 – Pyrograms of the outer rubber cover from a) an unused length and b) the failed length of Titan MIL-H-6615E batch SPO770-98-MYN62 refueling hose.

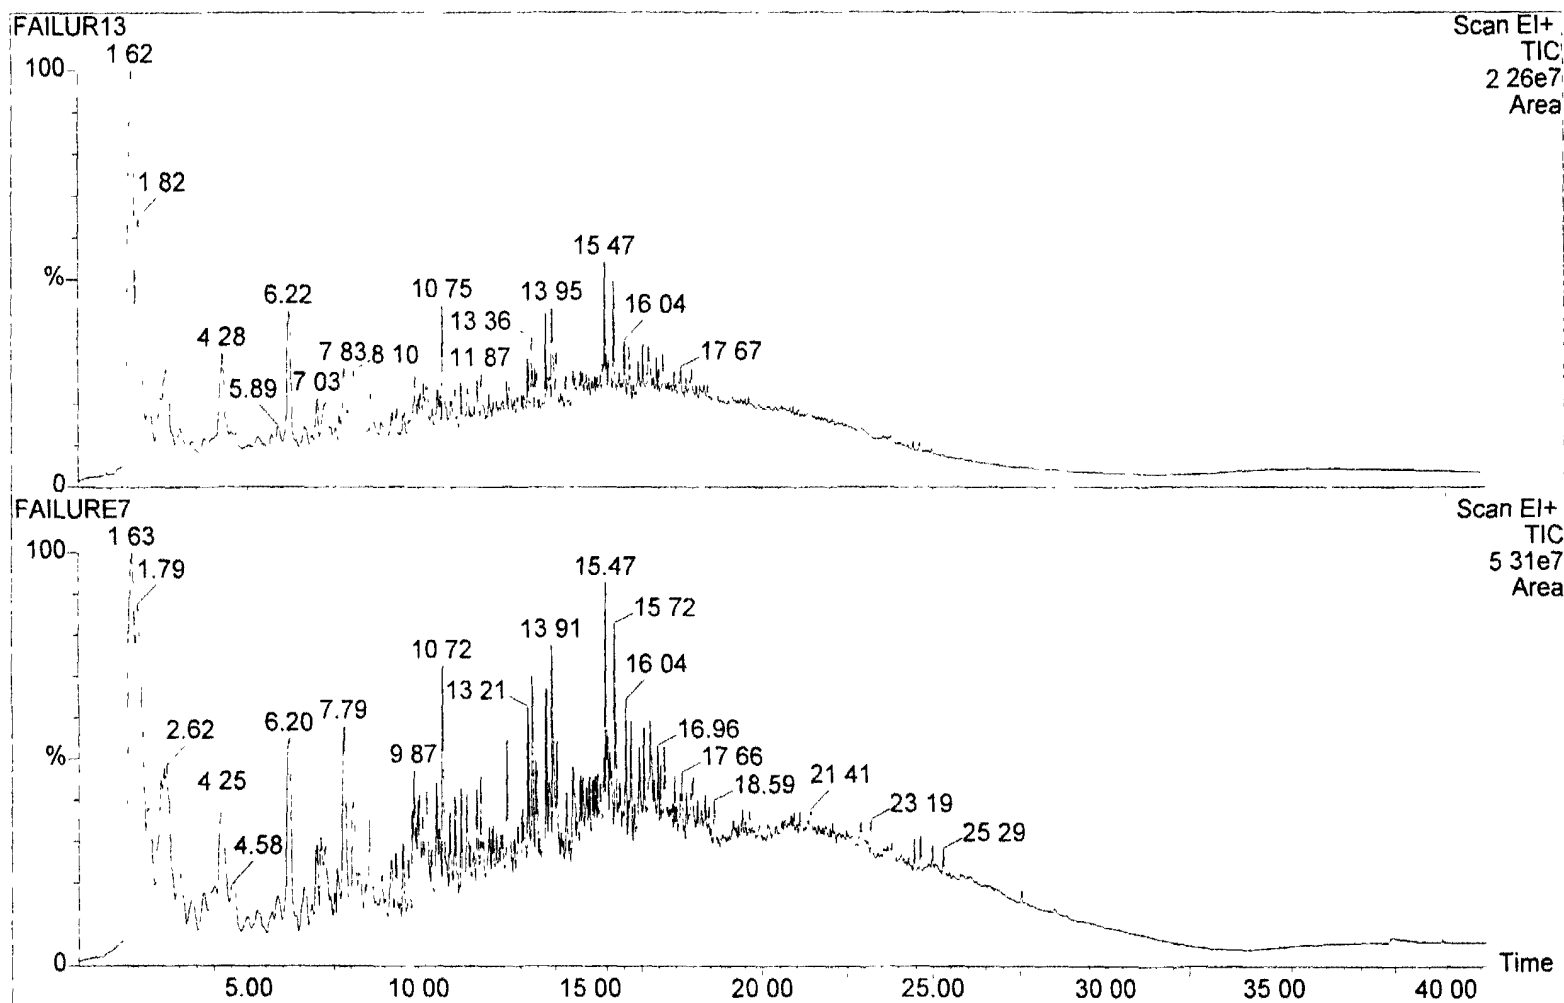
Figure 8 - Pyrograms of the inner rubber tube from a) an unused length and b) the failed length of Titan MIL-H-6615E batch SPO770-98-MYN62 refueling hose.

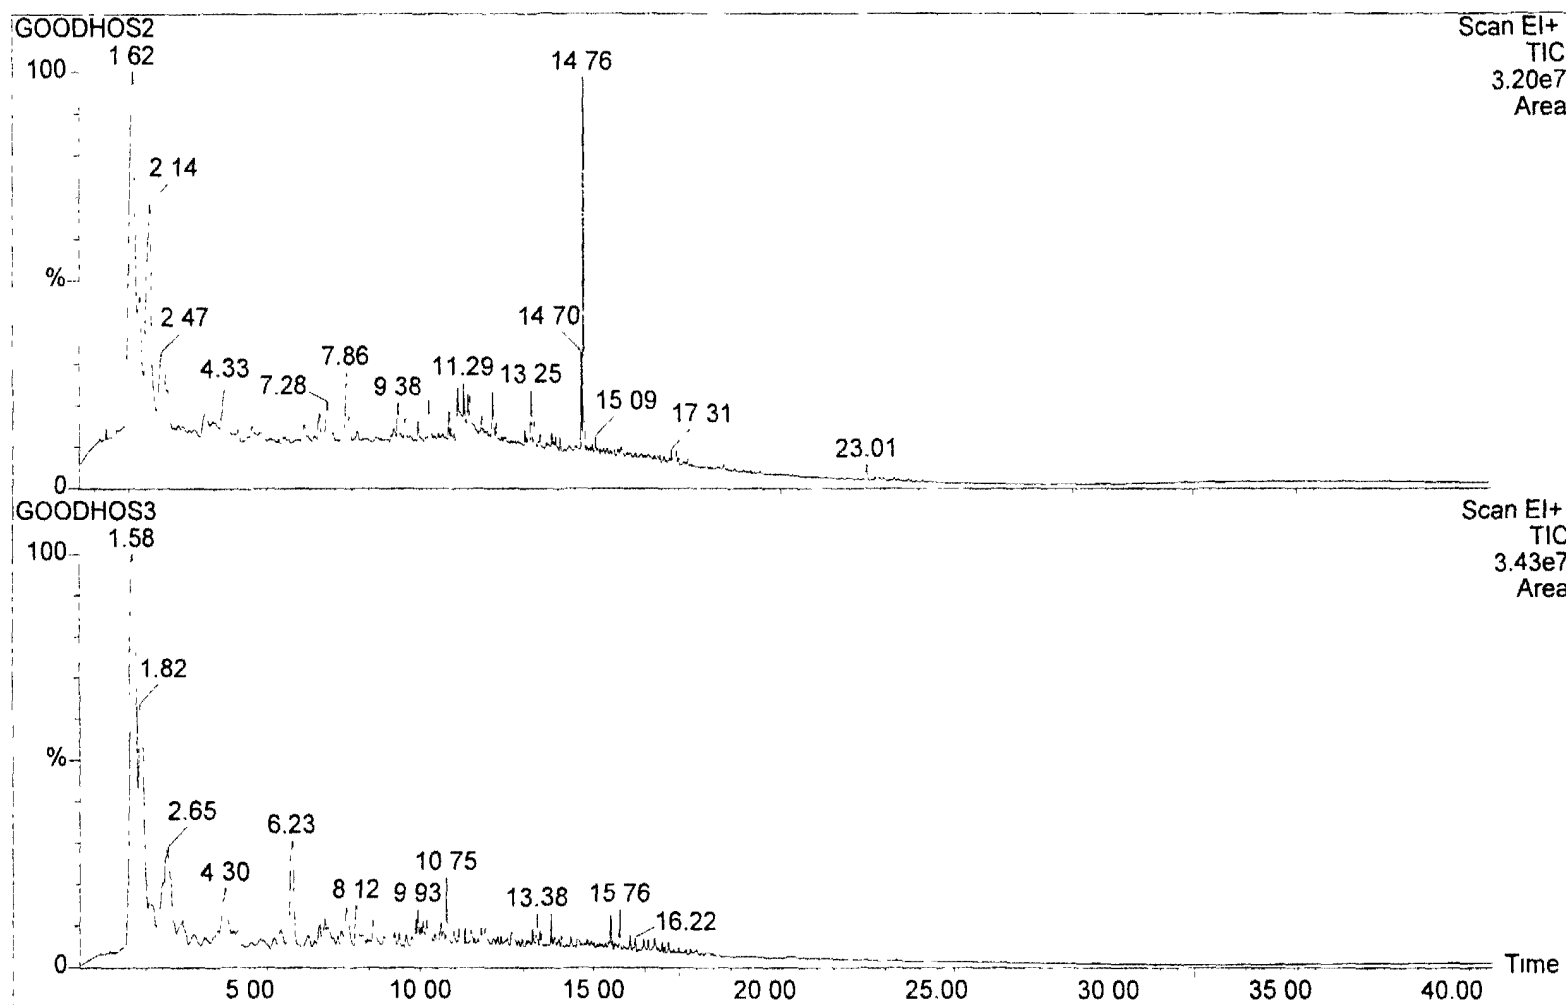
Pyrograms of the outer cover and inner tube of the 'German' hose are shown in Figure 10.

Figure 10 - Pyrograms of the outer cover and inner tube of the 'German' hose.

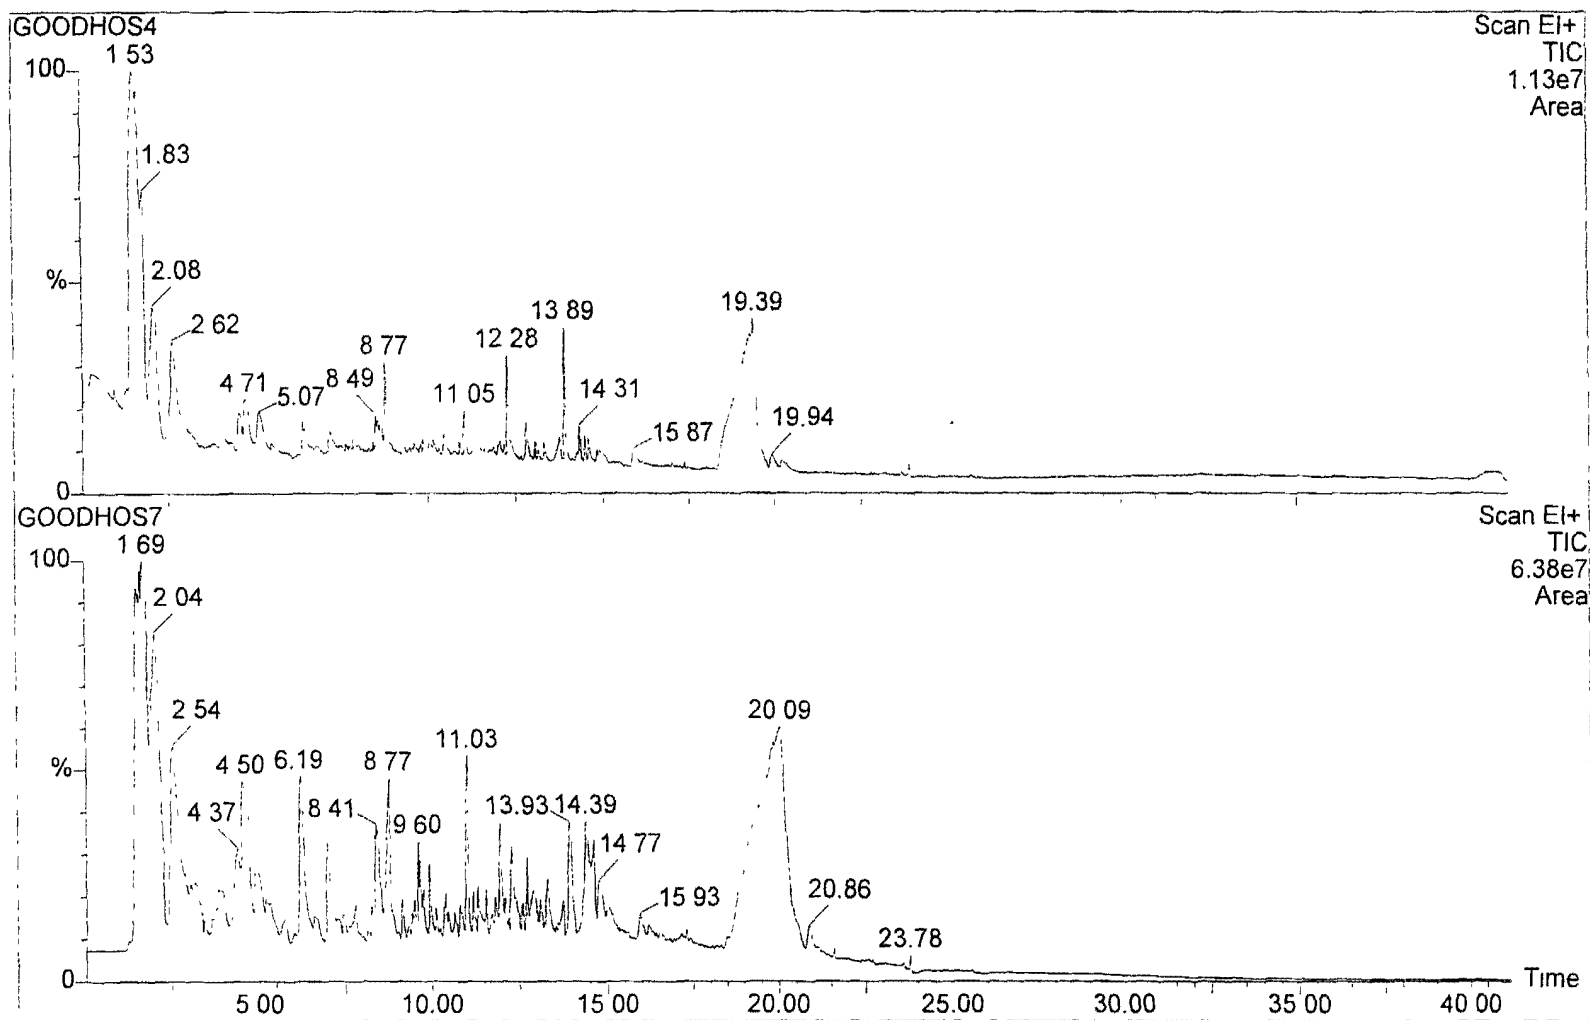
The pyrogram of the reinforcing fibre is shown in Figure 11a. Analysis of the pyrolytic degradation products of the reinforcing fibres indicated that they were consistent with a cellulose-based fibre similar to cotton. The pyrogram of a sample of cotton is shown in Figure 11b for comparison. Levoglucosan (1,6-anhydro-beta-D-glucopyranose) (19.39 minutes in Figure 11a), a major degradation product of cotton, is found in both pyrograms.

Figure 11 - Pyrograms of a) the reinforcing fibres from the 'German' hose and b) a sample of cotton.

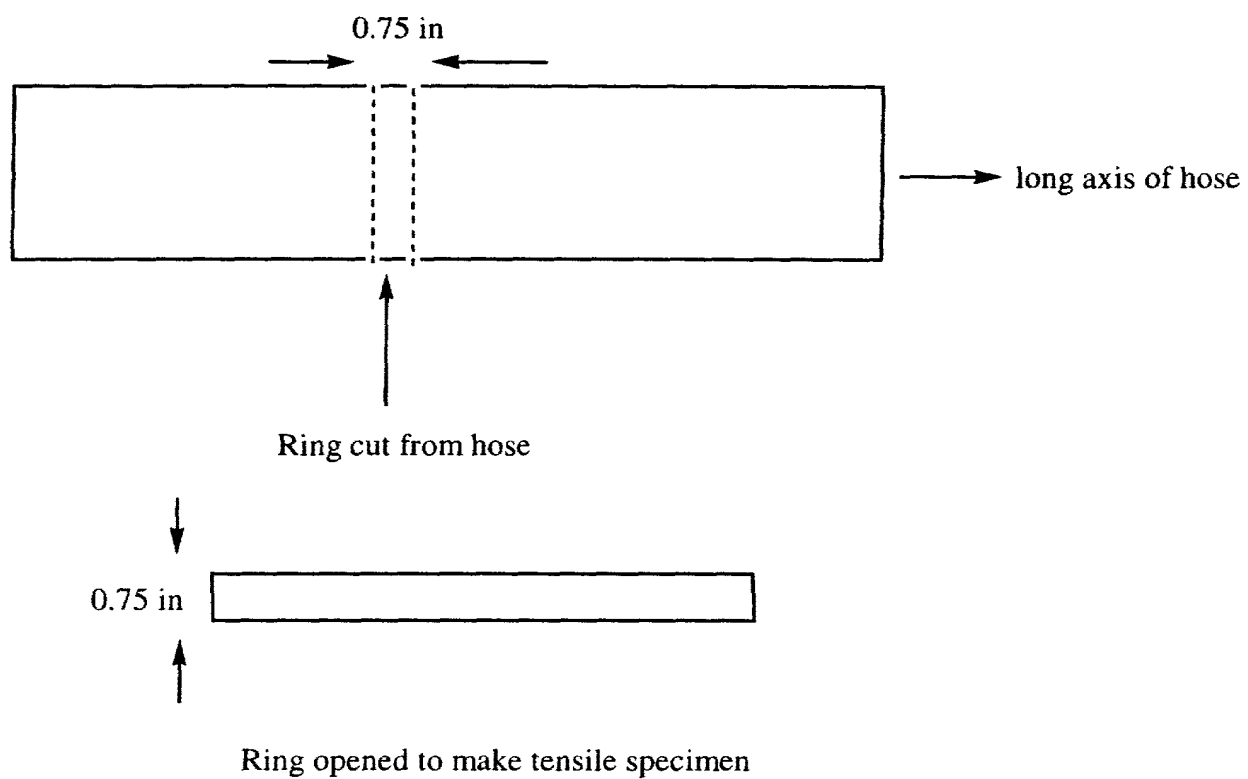
Figure 13 - Diagram showing preparation of tensile test specimens from hose samples.
